Worldwide repairs carried out with PolymerMetal®

REP-# 041

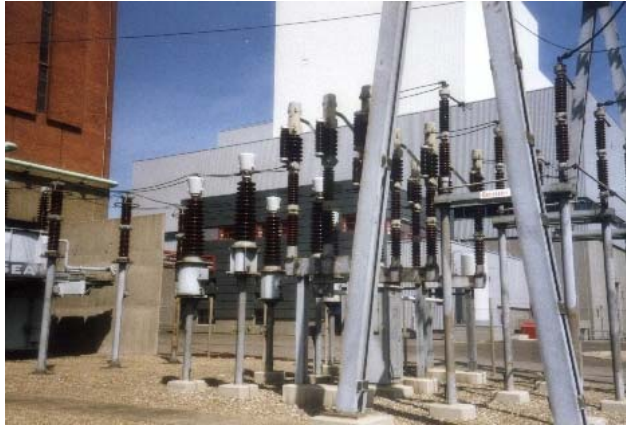
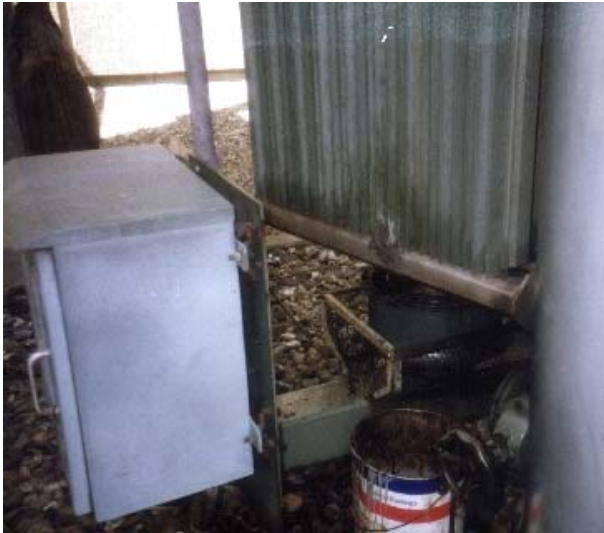
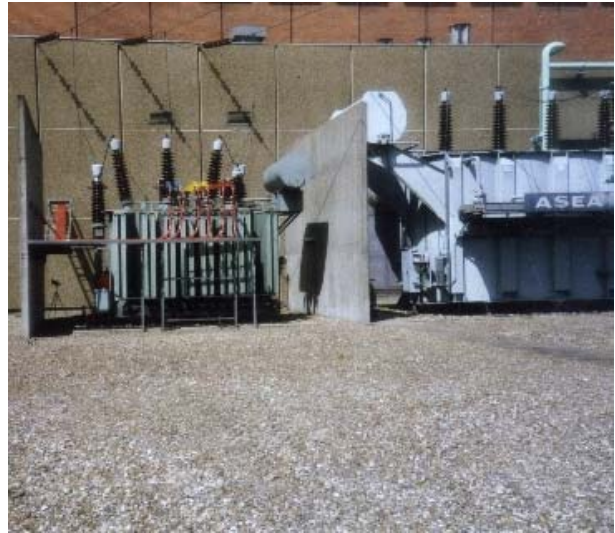
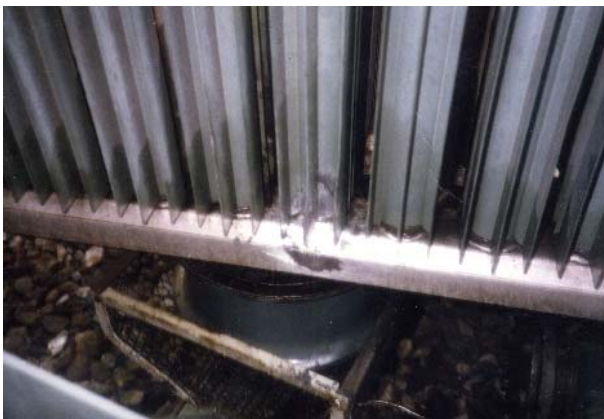
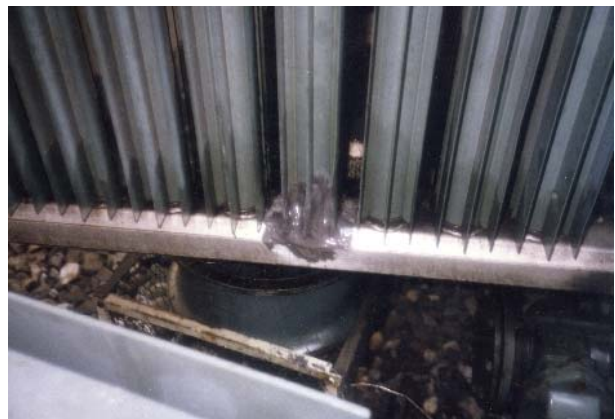
Sealing of a large transformer in a power station. The leakage was sealed with MM-metal oL-steelceramic and Hardener red using the direct-MM-bonding method. Then a layer of MM-metal oL-steelceramic and Hardener yellow was applied to the first layer.
