## Worldwide repairs carried out with PolymerMetal®

REP-# 072

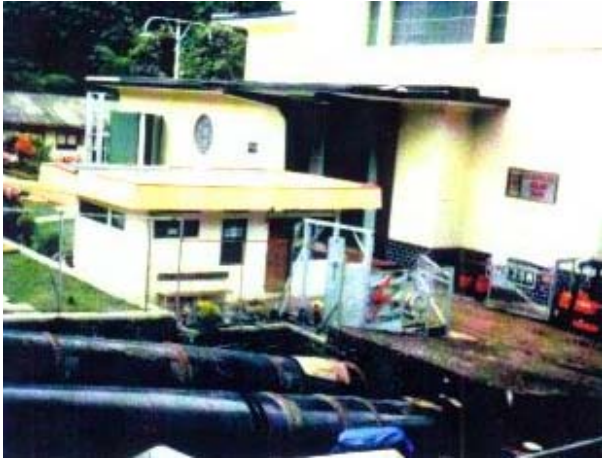
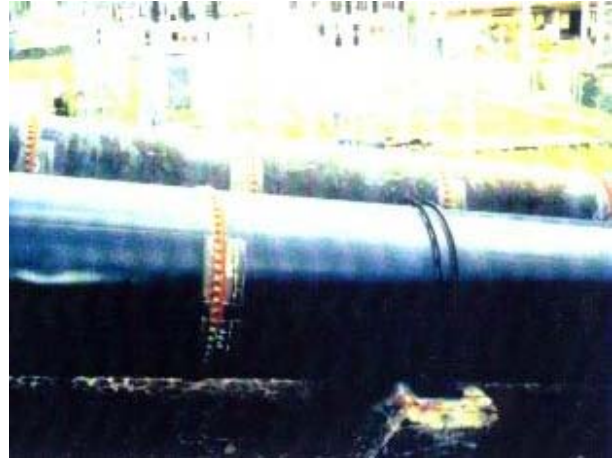
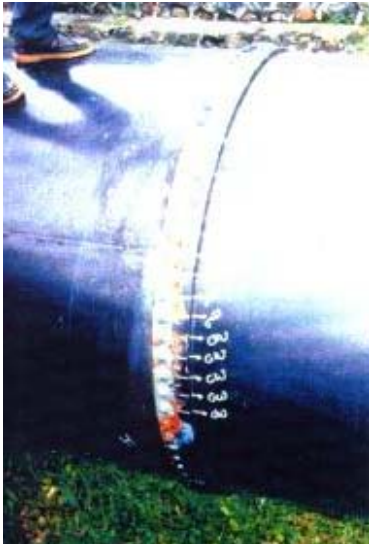
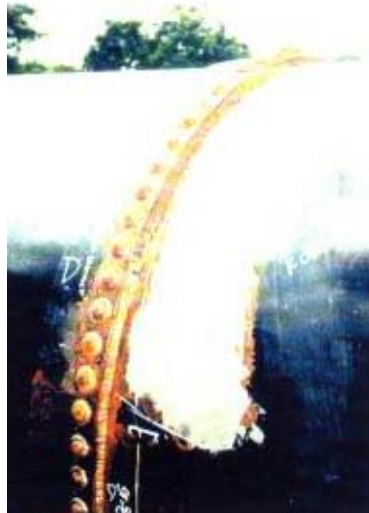
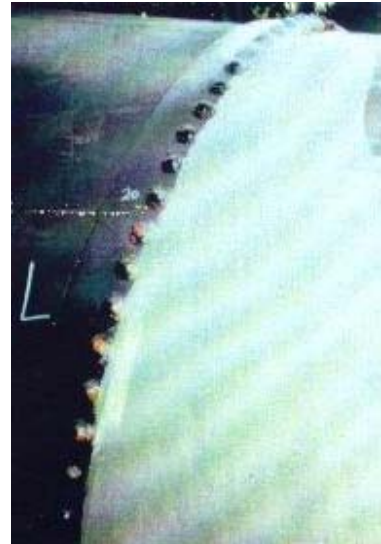
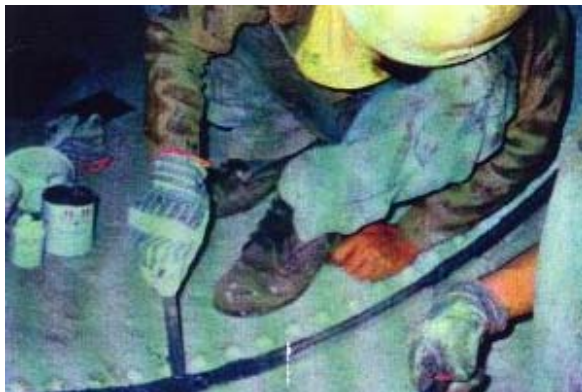
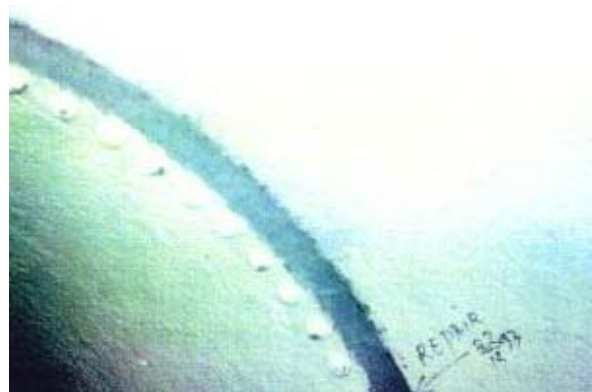
Coating of the inner respectively outer diameter of a penstock pipe with diameter appr. 1,5 m, length appr. 900 m. Damages were caused by erosion and abrasion due to water and sand. The coating was affected with Ceramium pasty with Hardener CE.
