*Worldwide repairs carried out with PolymerMetal®*

REP-# 126

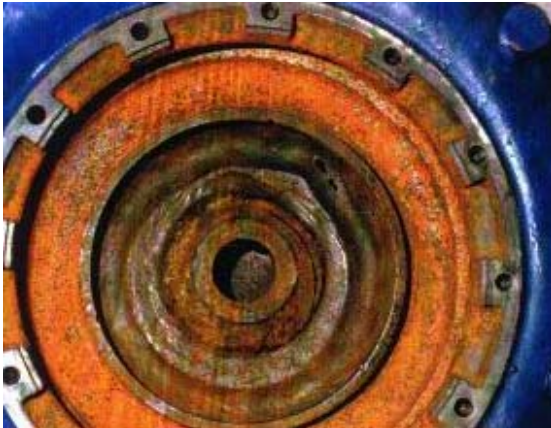
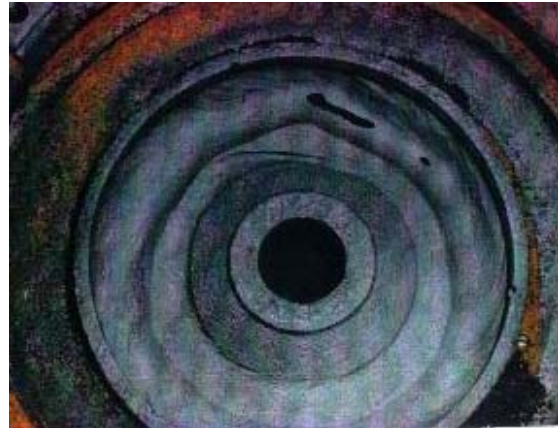
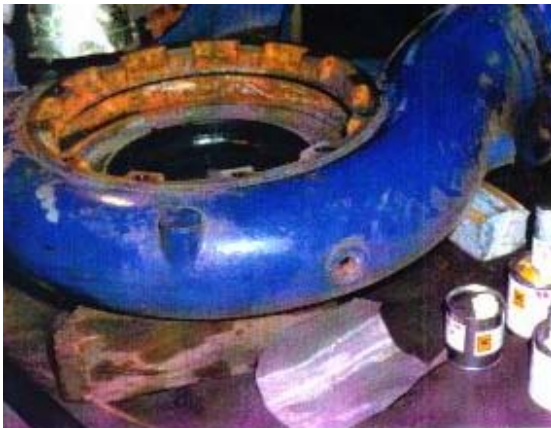
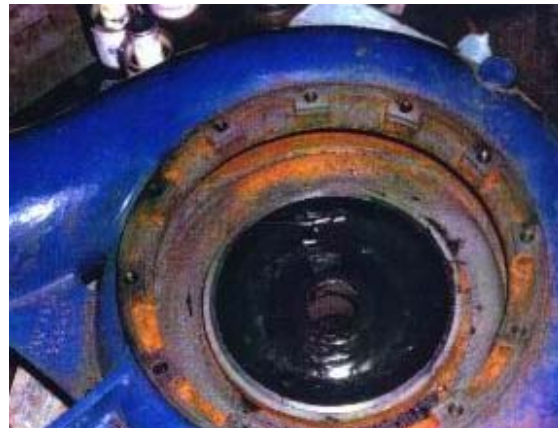
Repair of a pump housing. Damage: erosion and corrosion had reduced the wall thickness to a minimum. The resulting damage was a hole in the housing. For deep wash-outs Ceramium, pasty with MM-Fabric mats (steel) were used. For the purpose of wear-and-tear resistance the pump was coated with Ceramium, liquid.
